Manhole Inspection Summary

Manhole # S27I__033MH

Location Address: **39 S Poppleton St**

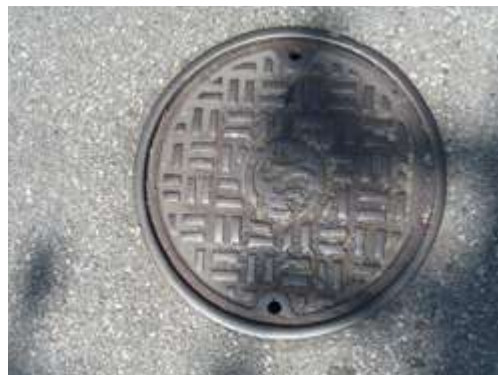
Cover View

Condition: **Worn**

Cover is worn and chipped

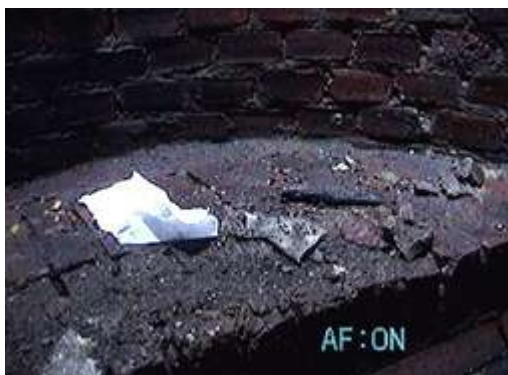
Defect 5

Condition: ☐ Sound ☐ Cracked ☐ Root Intrusion ☐ Deteriorated ☐ Leaks ☒ **Debris**

debris cond bench

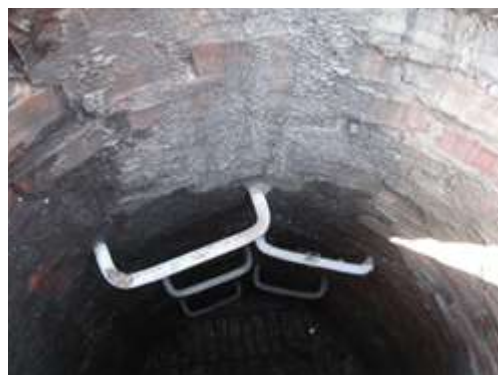
Defect 4

Infiltration: ☐ None ☐ Joint ☐ Cracks ☒ **Mortar** ☐ Roots ☒ **Wall**

corbel flow wall, corbel mortar

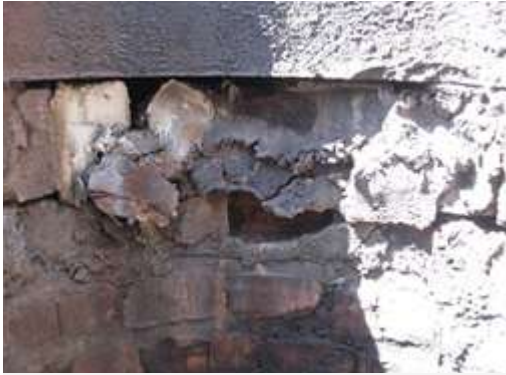
Defect 3

chimney cond loose bricks

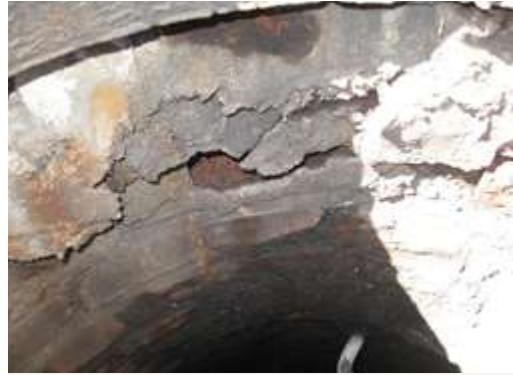
Defect 2

Condition: ☐ Sound ☐ Cracked ☒ **Leaks**

missing mortar/ infiltration coming from gap in chimney-frame

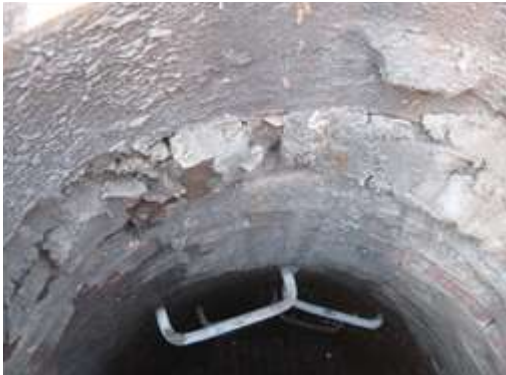
Defect 1

Condition: ☐ Sound ☒ **Cracked** ☐ Root Intrusion ☐ Loose Brick ☒ **Deteriorated**

Infiltration: ☐ None ☒ **Joint** ☒ **Cracks** ☒ **Mortar** ☐ Roots ☐ Wall

chimney cond deteriorated, chimney cracked, joint, cracks, mortar

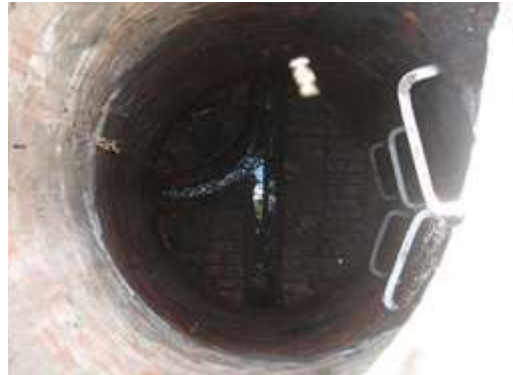
Defect 6

Infiltration: ☐ None ☐ Joint ☐ Cracks ☐ Mortar ☐ Roots ☒ **Wall**

barrel flow wall
